# MIKE O'RYZIE AND THE CANOPY OVER THE CARS

**This case began with a bad decision on tree care three years ago and evolved with the involvement of lawyers, scientists, consultants and contractors. It won't end anytime soon. It takes place in one city in the south-eastern USA, so the legal context may be unfamiliar to arborists who work in other jurisdictions. The species and climate may also be different. But the biology, politics, and arboriculture relate to urban tree care everywhere, so I hope readers find this case relevant to their work or at least an entertaining diversion from their daily grind.**

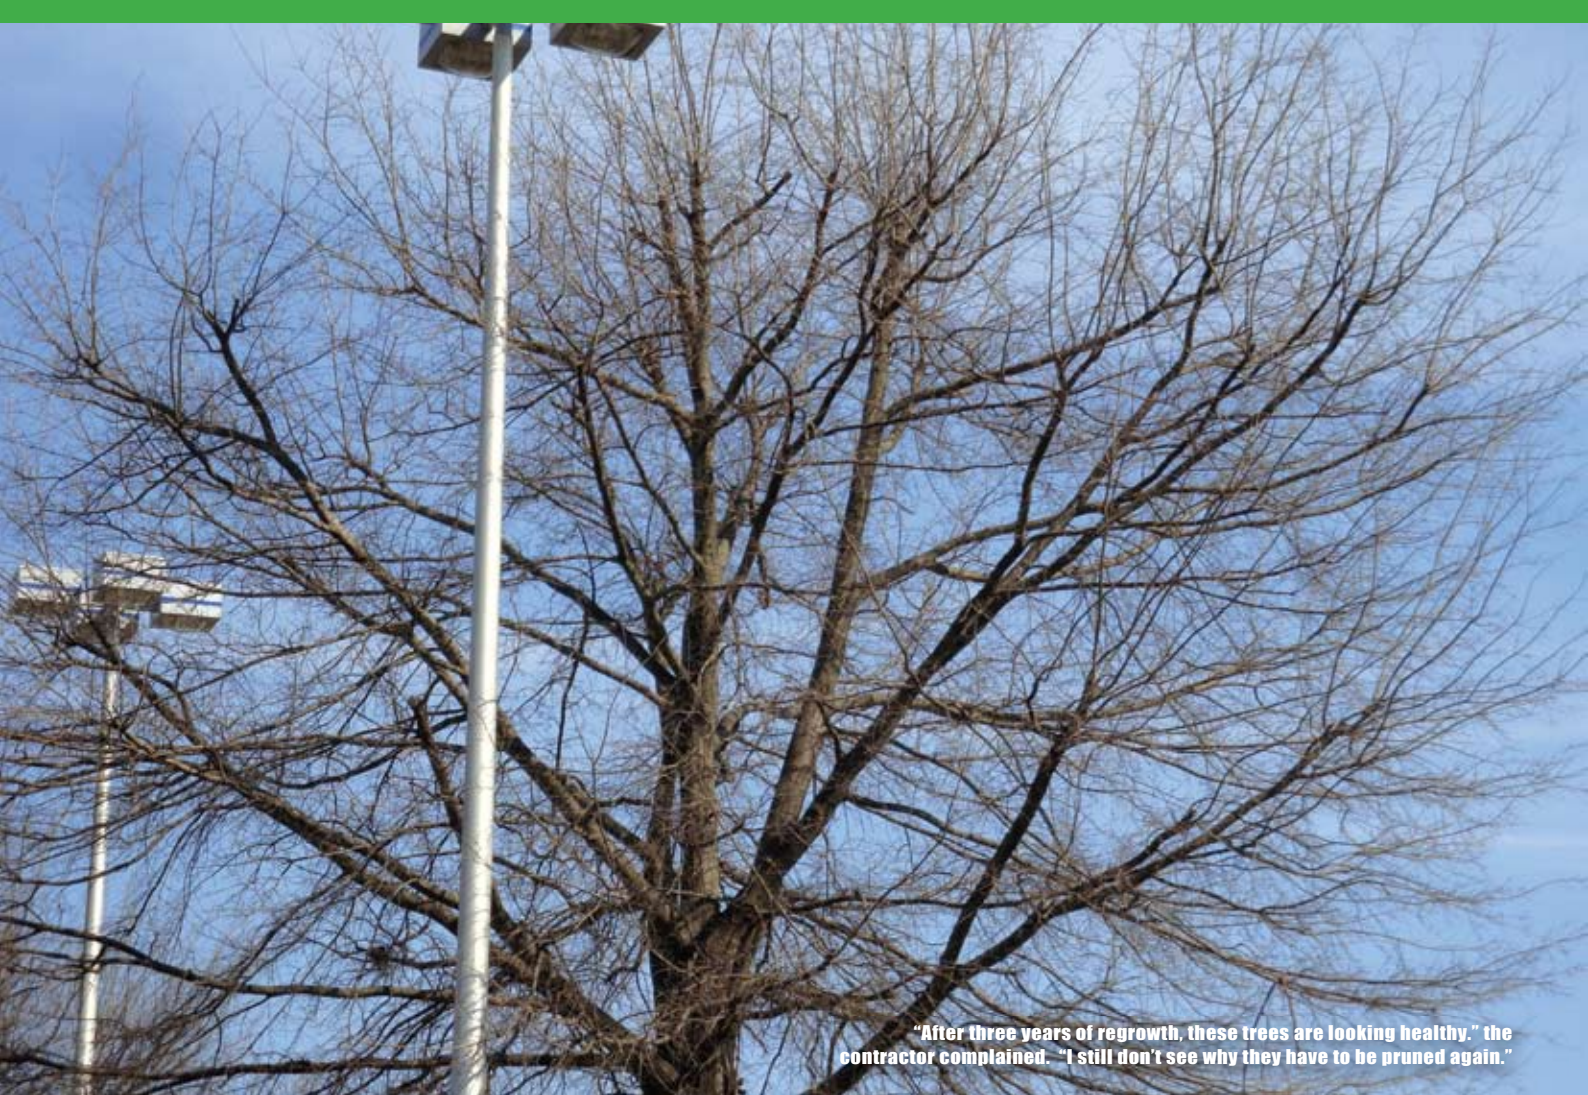
The City called this round over job a crime, but the perpetrator pleaded innocent: "We pruned these Quercus just like we do our Buxus, and they come back just fine. There's nothing wrong with this pruning job."

On site I could see the roots were constrained by the curbing, pavement surrounding the small islands, and lack of mulch. The central stems in the top of the trees, the 'main leaders', had been cut back to a pre-determined crown limit, the height of the light poles. This is by definition 'topping' and not compliant with the ANSI standards or the International Society of Arboriculture (ISA) Best Management Practices (BMP) on tree pruning. The largest wounds are about ten centimetres in diameter. The side branches were also cut back, less severely. Crown loss was estimated to range from 30 to 50 per cent. After reviewing all this information, the client's lawyer asked again; why the rules were that way, what was wrong with the way the trees were pruned, and whether they would die. My response was submitted and negotiations for a settlement with the city's lawyers began.

3. Restoration pruning, following the standards and BMP’s, can allow all the trees to regain their health and form over time. We have managed hundreds of mature trees of the same species, especially after a storm in 2002 which broke a lot of branches off. Without care the new growth will be destabilised by decay, defective attachments and prone to further breakage later on. I recommend reducing the stubs back to good laterals properly spaced, with the cuts sloping away from the sun where possible, along with soil improvement.

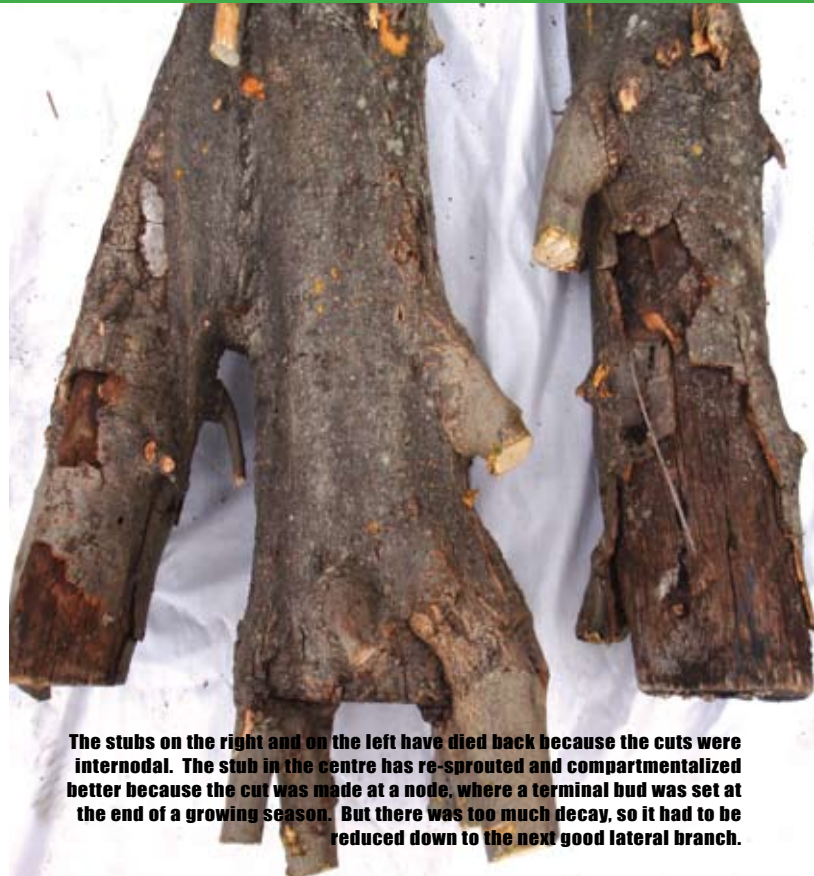
The pattern of dieback from the internodal cuts made in 2006 was extremely instructive. A few sprouts came off the stubs at odd locations, apparently growing from adventitious buds that were newly formed in response to the round-over pruning, but these did not thrive. The stable re-growth occurred further back in clusters from dormant buds that lay waiting. These were originally accessory buds, formed when the terminal bud was set at the same location on the branch when it was just a one-year old twig. These dormant buds are carried out in the cambium as the branch expands, still connected to the core by pith trails. These dormant buds are held fast in the core of the tree as they are nourished by the vascular stream.

Decay spread downward through these stubs until it met the branch protection zone at the nodes. There, the trees were able to draw the chemical lines with phenols and other natural wood

The stubs on the right and on the left have died back because the cuts were internodal. The stub in the centre has re-sprouted and compartmentalized better because the cut was made at a node, where a terminal bud was set at the end of a growing season. But there was too much decay, so it had to be reduced down to the next good lateral branch.

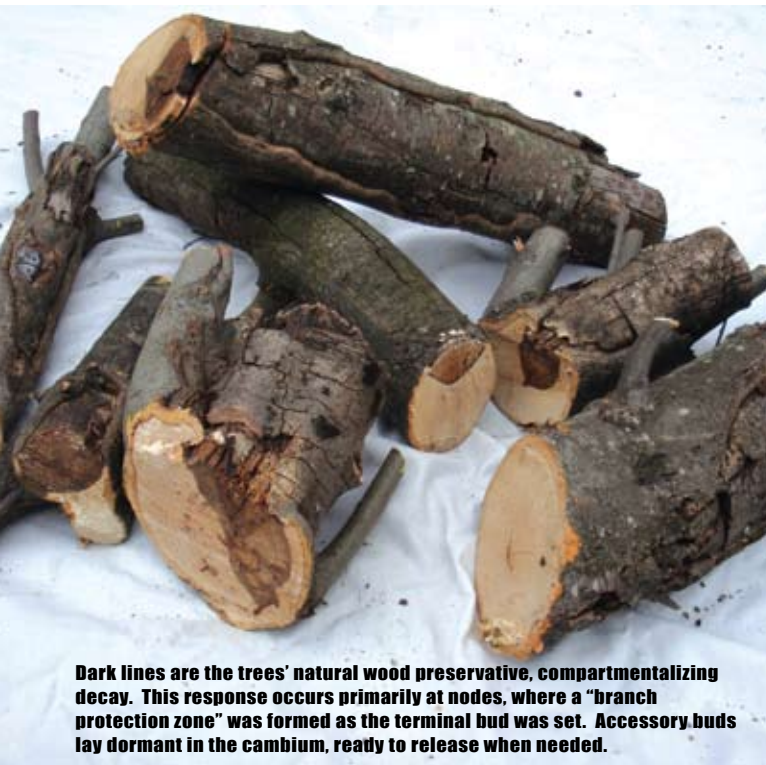
**Dark lines are the trees' natural wood preservative, compartmentalizing decay. This response occurs primarily at nodes, where a "branch protection zone" was formed as the terminal bud was set. Accessory buds lay dormant in the cambium, ready to release when needed.**

preservatives and the decay was compartmentalised. There at the nodes, meristematic tissue went to work, cells divided and elongated. Buttresses were formed at the base of the new growth, strengthening it against the possibility of future breakage. Had the original cuts been made to these nodes, decay would be better compartmentalised. That may be why ANSI's definition of 'topping' was changed in 2008 to include making 'internodal' cuts. This prohibition applies to most shrubs, as well as trees. As Dr. Alex Shigo said, "Proper reduction cuts are made at nodes, or crotches." But as is often the case, arborists come in to clean up someone else's mess, following Best Management Practices by the Best Means Possible.
